Copper and Zinc Phytoremediation by Native Herbaceous and Grass Species Colonized on Remediated Soils at the Bullion Mine, Montana

By: Matthew Wenzel

Dr. Erika R. Elswick, faculty mentor
Dept. of Geological Sciences

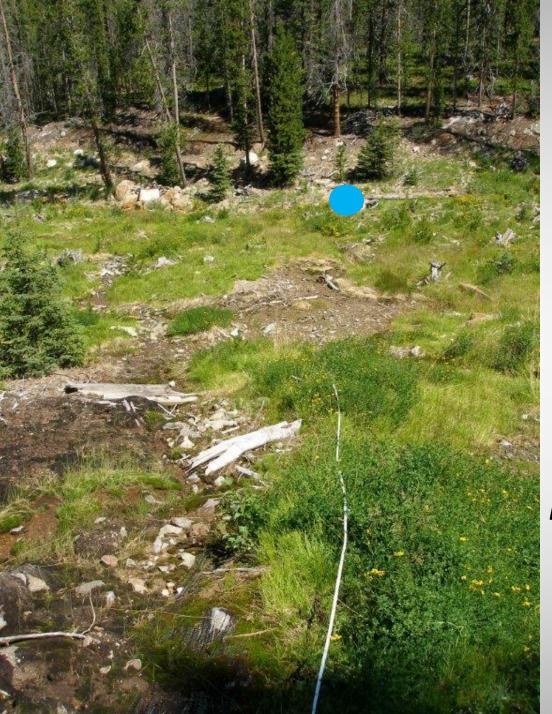
Transect view north from 60 m

Note patchy plant distribution
